# A Neighborhood Planning Study

West Lakeview Avenue is a small South Clintonville street, consisting of 85 houses, located midway between North Broadway and Weber Road, and extends west from High Street to the Olentangy River.

City of Columbus Mayor Tom Moody

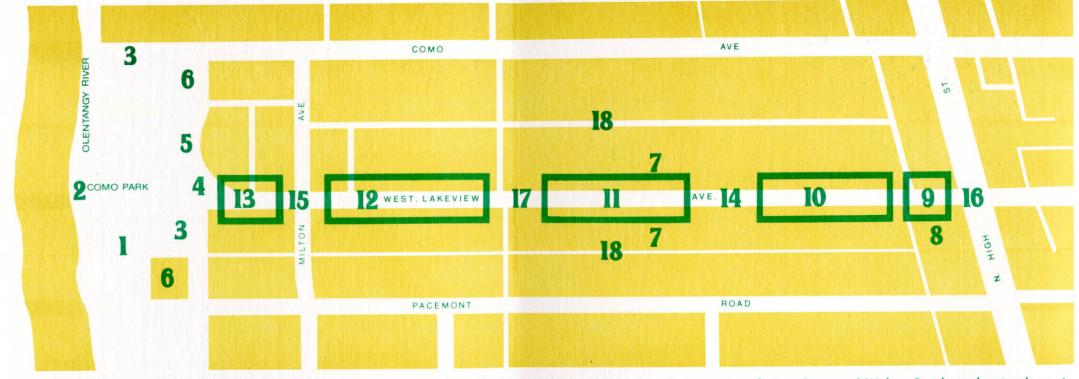
# Proposed Improvements

#### Como Park

- I Improved Tot Lot Facilities
- 2 A River Viewing Area
- 3 New Bleachers & Terraced Seating
- 4 A Designed Park Entrance
- 5 A Buffer From Residential Areas
- 6 Potential For Developed Parking Areas (Expensive Long Range Proposal)

#### **Private Property**

- 7 Cosmetic Improvements Of Some Structures
- 7 Maintenance Of Structures & Yard
- 7 Provide Adequate Off-Alley Parking Facilities
- 7 Use Of More Landscaping
- 8 Commercial Parking Improvements

#### Streets

- 9 Special Sidewalk Treatment & Landscaping
- 10 New Tree In-Fill To Form Dense Tree Cover
- II New Small Shade & Flowering Trees At Random
- 12 Shrubs, Ground Cover, & Flowers With Some New Trees
- 13 Formal Tree Planting To Form Entrance
- 14 Landscaping Nodes At Various Points Along The Street
- 15 Treatment Of Intersection To Define No-Outlet & Park Entranceway
- 16 A Street Identification Feature
- 17 Improved Street Lighting

#### Alleys

- 18 Surfacing
- 18 Lighting

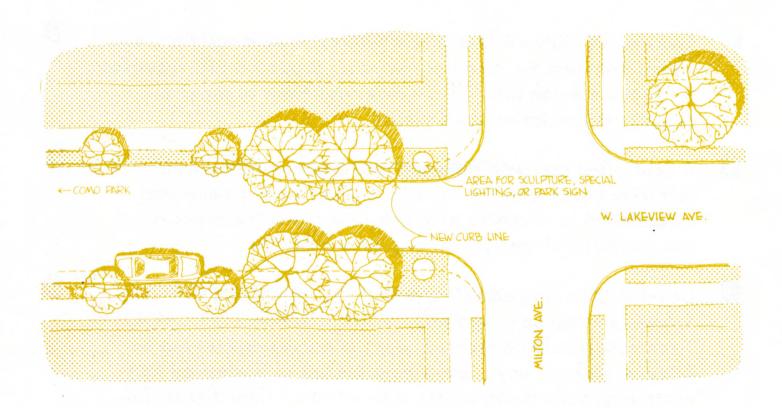
A potential development for a park entrance way involves curb protrusions which allow space for plantings and an entrance feature. It would also help indicate there is no outlet.

Create landscaped gateway from Milton Avenue to the park.
- Lighting improvements are scheduled for 1982. Encourage private lighting and small scale walkway lighting.
- Report incidents to Animal Control. Educate pet owners on their responsibilities.
- Request more Police visibility and establish communication with Cruiser #44 officer.
  Encourage planned activities for teenagers.

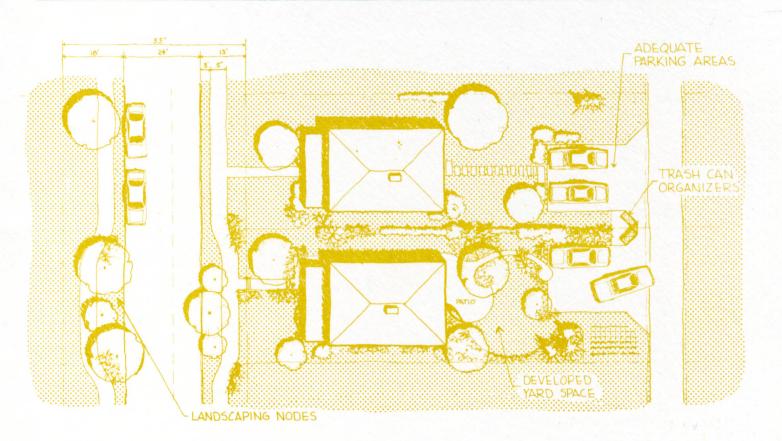
Shown are two examples of property development involving coordinated service areas and different landscaping schemes. Landscaping nodes physically and visually enhance the streetscape.

Improved alley conditions are needed to encourage the use of off-alley parking and to alleviate the on-street parking situation. The unpleasant surroundings of the alleys discourage their use, which in turn promotes the growth and continuance of undesirable conditions, such as weeds, scattered trash, and broken glass. Generally, the less backyard spaces are used, the more cluttered and unkempt the alleys become. On properties where off-alley parking spaces are used, the backyard areas are usually better kept and more useable. The development of such backyard areas and off-alley parking spaces will not only help the parking situation, but will improve the area's environmental quality. (See sketch showing potential lot developments on page 13.)

Create landscaping nodes on the street as shown by sketch.
- Develop overall plan with the Department of Recreation and Parks.
